THE CASTLE OF CERRETACCIO STUDIES FOR THE MATERIAL HISTORY AND CONSERVATION

AMBRA MARAMAI
UNIVERSITY OF FLORENCE

MICHELE COPPOLA
UNIVERSITY OF FLORENCE

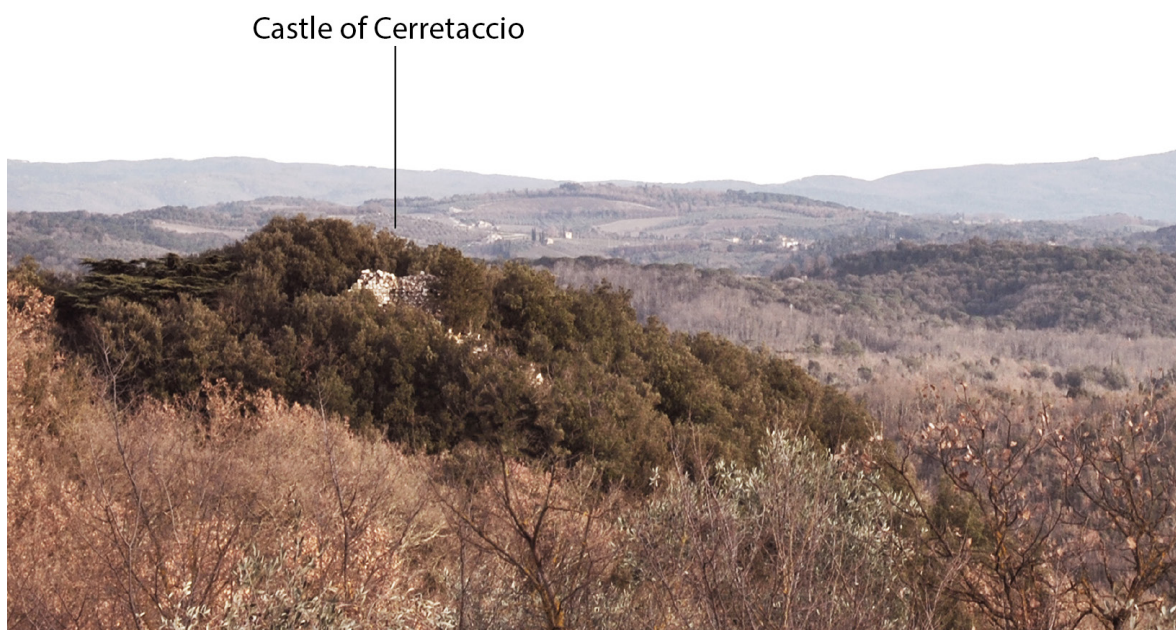
Fig 1. View of the Castle from the Cerreto road..

The present study analyzes one of the many castles of the Chianti area, the Cerretaccio Castle (Fig.1). The importance of the site is linked to historical and architectural features that distinguished it in the Middle Ages in the context of the clashes between Siena and Florence. The collapse of the tower, which today appears as a series of fragments scattered on the ground, contributes to the interest of the place. The goal of our study is to analyze the ruins of the building and hypothesize its original state, in order to understand the causes of degeneration and collapse and suggest interventions or protection measures. The study consisted of an overall investigation of the area and a specific study on the tower. The digital survey allowed the planimetric and 3D reconstruction of the site. All the fragments resulting from the collapse of the building have been acquired and this has allowed a virtual reconstruction that could return a credible hypothesis of the configuration of the structure before its collapse. The result made it possible to proceed according to the methods of building archaeology, using tools to deepen the typological investigation of the building, allowing to know its materials and construction techniques, typological variations and to hypothesize a placement with respect to the walls. Thanks to the support of structural modelling, it was possible to clarify the possible options related to the collapse of the tower. Issues related to the state of conservation of the entire site were also examined in depth. From these investigations we started an overall analysis for the protection of the site,

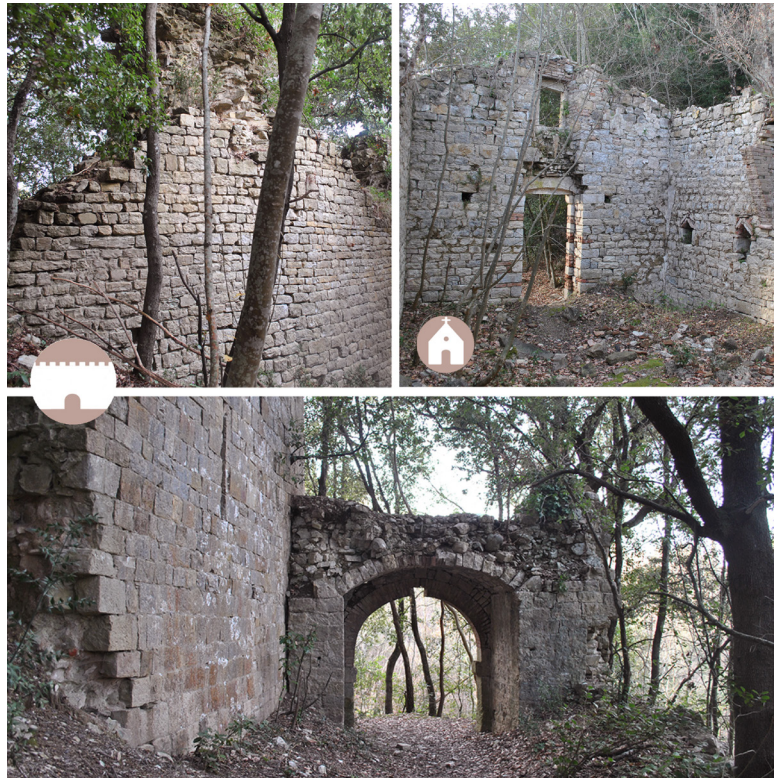
Fig 5. Views of the boundary wall and the church.

The results of the survey highlighted a draw of the boundary wall modelled on the design of the promontory on which it is located. Inside it develops an area of about 3000 square meters (Fig. 3). The area is largely occupied by the remains of the tower that involve the northern portion of the complex and are positioned parallel to the long side of the wall (Fig. 4). This seems to be surrounded by a second development of walls that suggest a second building circuit following the first one. Outside of both we find the Church of Santo Stefano to the south-west and the source to the south (Fig. 5).

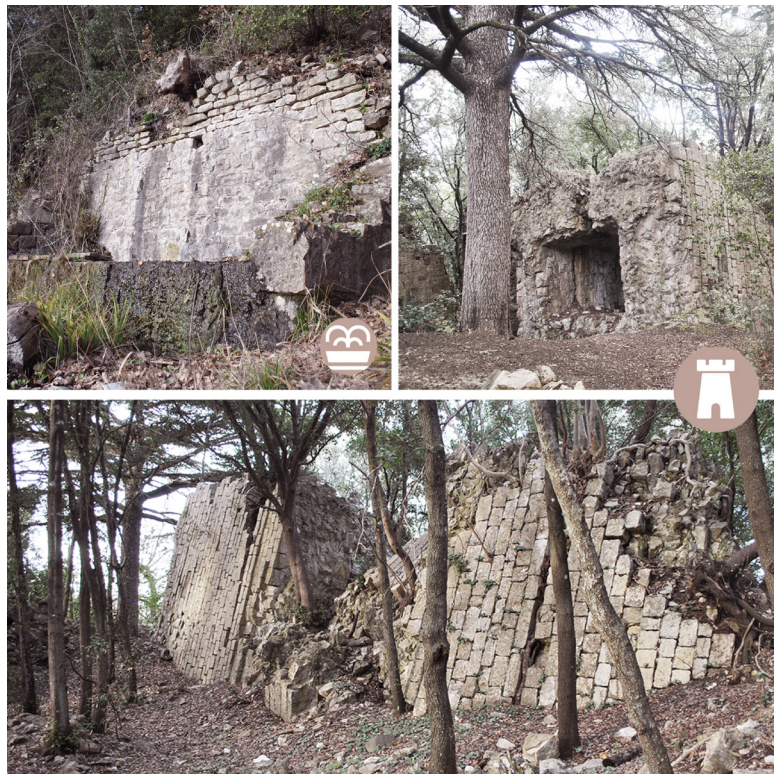
Fig 6. Views of the tower and the fountain.

Outside the wall circuit there is, in addition to the church, also a fountain located south of the complex whose access had to be guaranteed by a primitive staircase (Fig. 6).

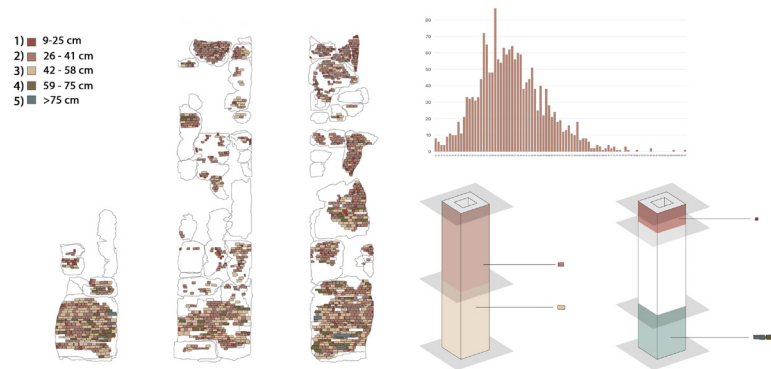
Fig 9. Typological study of segments in width.

The parameters taken into consideration in this phase concerned a rather large population, as they refer to the entire face of the three fronts investigated (Coppola, 2018). The work focuses on three aspects: study of the dimensions of all the segments of the masonry in width (Fig. 9), dimensional study of rows in height (Fig. 10), study of horizontals (Fig. 11). As regards the first two phases of the study, a scrupulous measurement of width and height was carried out for all individuals in the population. After data collection, it was necessary to report the same in diagrams to view the distribution trend. Dimensional classes are set on the diagram to simplify the reading on the high side. The address, both as regards the dimensioning in width of the segments and as regards the height of the rows, is to use dimensional classes with regular pitch and check how the elements are distributed within them. Once the classes had been established and identified with a colour, it was advisable to fill in the elements belonging to the specific class with the reference colour. It is clear that the data that emerged cannot lead either to an absolute dating of the masonry or to a specific identification of circumscribed USM. It is well known that what emerges from the typological analysis is not a certain and unequivocal fact but represents the possibility of identifying even minimal variations on it. In light of this, the results obtained can be said to be satisfactory. It was possible to identify homogeneous and diversified characters and proceed with an investigation on the latter. The variables found are attributable to the

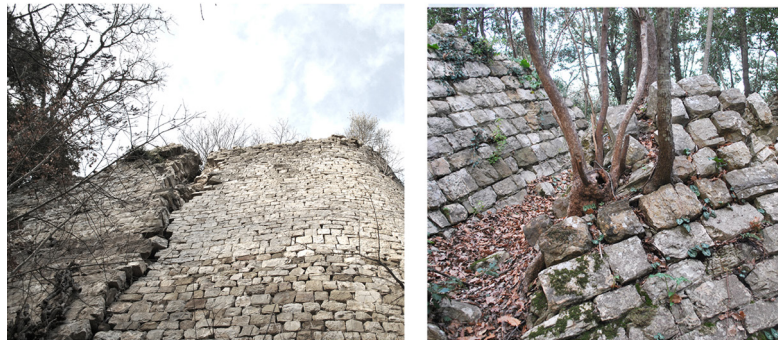
Fig 14. Main degenerative phenomena of the fortification.

The macroscopic phenomena common to the whole area are generally linked to the evident state of neglect of the property. In more significant phenomena are linked to two aspects: the presence of vegetation and the infiltration of rainwater (Fig. 14). The lack of material on the wall crests would have exposed the masonry more to degenerative phenomena. The loss of

the crown must have allowed the infiltration of rainwater into the inner core and the rooting of the vegetation. It is probably for these reasons that most of the injuries were created. In many cases the crack pattern has produced a more or less consistent loss of material. In the south-eastern section of the boundary wall, the phenomenon caused an important fracture in the thickness of the entire wall section which seems to have caused the detachment of the two contact fronts. One of the two portions into which this section of the boundary wall is divided, is progressively losing its original position, assuming a position outside the vertical plane.

As for the tower, it owes its state of decay to the unusual position it occupies today. A masonry that is designed to remain in a vertical position, free on all four sides suddenly finds itself in contact with the ground. All those phenomena linked to the rising damp from the ground (stains, biological organisms) that affect the portion of the fragments adhering to the ground are connected to this accidental location.
